Seismic evaluation for two rural housing prototypes Built with hollow concrete blocks, in Ocuilapa of Juárez, Chiapas, Mexico

L. Escamirosa ^{1*}, M. Ocampo *, C. Del Carpio *, R. Arroyo **

* Universidad Autónoma de Chiapas, Chiapas. MÉXICO

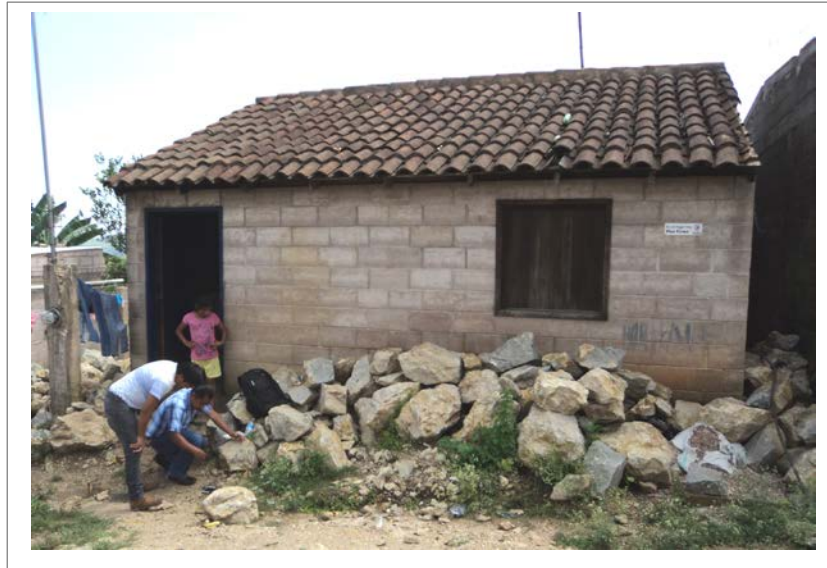
Figure 4. Location of the V1 dwelling (Reyes B., 2015)

The V1 dwelling, with geographic coordinates: 16°51'28.99" N and 93°24'53.62" O, is located on the 16 de Septiembre street and its owner is Mr. Crescencio Pérez Pérez. The house was built approximately 6 years ago (Figure 4 and

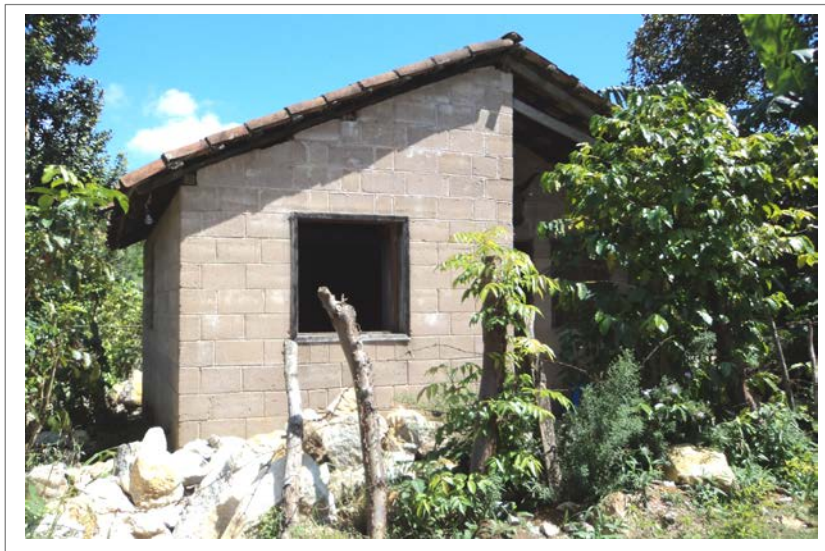
Figure 6. Location of the V2 dwelling (Reyes B., 2015)

Figure 5). The V2 dwelling, with geographic coordinates: $16^{\circ}51'30.52''N$ y $93^{\circ}24'43.96''O$, is located on the Ignacio Allende street and it is owned by Mrs. Norbel Jiménez Pérez (Figure 5 and Figure 6).

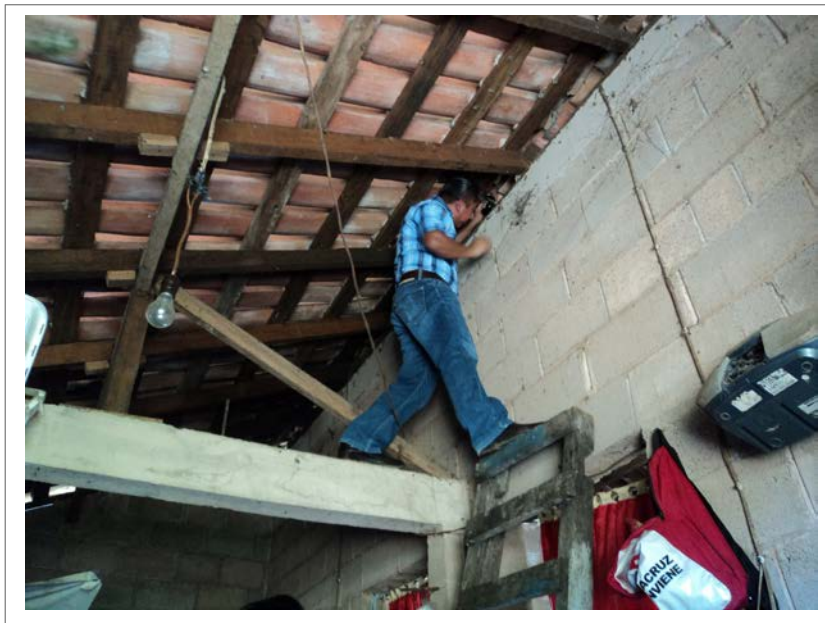
Figure 7. Positioning the sensor in the geometric center P3 of V2 (Reyes B., 2014)

Figure 7 shows the positioning of the accelerograph in the V2 dwelling at the indicated P3 point, which corresponds to the geometrical center. The obtained recordings were made in three orthogonal directions with a duration of 30 seconds. The results of the study establish that the average fundamental

periods of vibration per housing, are the following: dwelling V1 with 0.1280 seconds and dwelling V2 with 0.1067 seconds. Moreover, the corresponding soil measurements in the analyzed zones are: V1 with 0.1164 seconds and V2 with 0.1219 seconds.

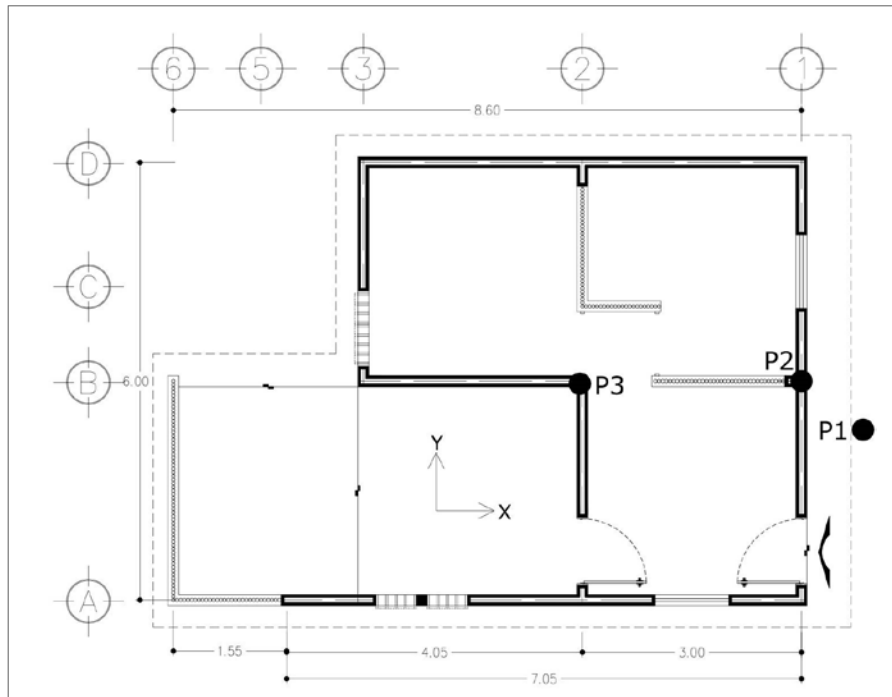
Figure 8. Sensor position in the V1 dwelling

Figure 8 and Figure 9 show the positions of the acceleration sensor in the structure of each dwelling (P2, P3 and P4) and in the free field (P1; soil).

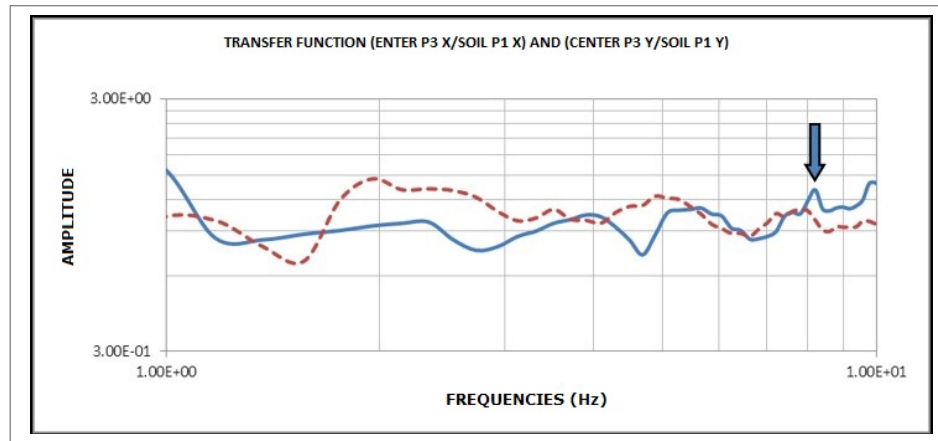
Chart 1. Transfer function of the V1 dwelling

Charts 1 and 2 show the transfer functions in each dwelling. The continuous function corresponds to the short direction of the house (x) and the discontinuous function corresponds to the long function (y). These functions were obtained by dividing the Fourier spectra calculated from the accelerometer recordings at the center of each dwelling (Point

P3), and the soil (Point P1). The relationship between both recordings allows establishing how the response is amplified in point P1 in relation to point P3. The charts highlight the frequencies that generate a wider amplitude of the spectral response. Next, the transfer function, or spectral ratio, was determined using the technique of (Nakamura, 1989).

The results demonstrate that the average fundamental period of the V2 dwelling, with 0.1067 seconds, complies with the recommended range for a structurally sound house, between 0.08 to 0.12 seconds, established by (Hernández et al., 1979) in studies with instrumentations made in dwellings of the state of Guerrero, Mexico, in 1979, and by Arroyo et al. in 2010. However, they show that the V1 dwelling, with 0.1280 seconds, exceeds that range.
