Control of Finished Work – Final Quality Inspection in a Social Housing Project

Control de la obra terminada – inspección final de calidad en un proyecto de interés social

Francine Berghan Finger*, Marco Stumpf González.^{1*}, Andrea Parisi Kern*

* Universidade do Vale do Rio dos Sinos (UNISINOS) - PPGEC. BRAZIL

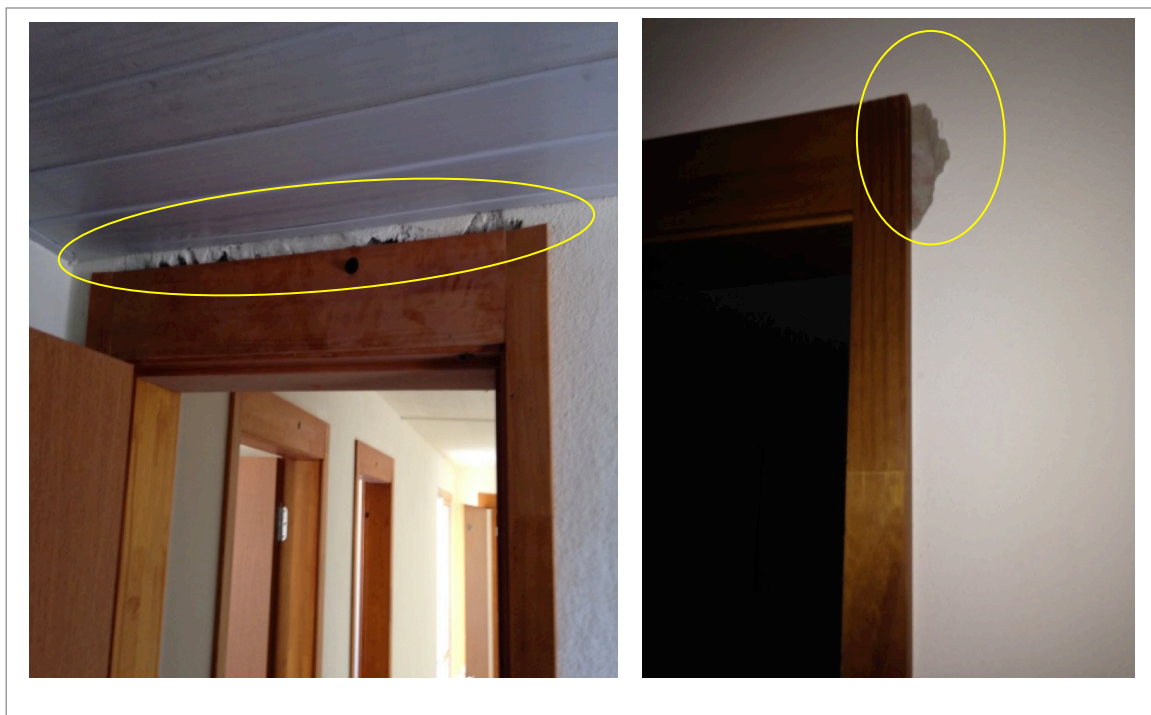
The review of the inspection reports that described the rejection reasons, points out that the most common complaints for coverings were the damage present in the smooth plaster and/or paintings, as can be appreciated in Figure 3. In the ceramic tiles, 35% of the complaints refer to the damages in the ceramic tiles (some of them broken) and the 50% are problems with the joints (appearance and variable joint widths). These problems were not adequately solved in all the units and, in consequence, they were mentioned again in the second inspection.

Figure 3. Examples of problems in the interface between the wood flashings and plaster. Source: authors
